AERONÁUTICA CIVIL
UNIDAD ADMINISTRATIVA ESPECIAL

REPORTE TÉCNICO DE REDES DE MICROONDAS
DIRECCIÓN REGIONAL CENTRO SUR

NEIVA

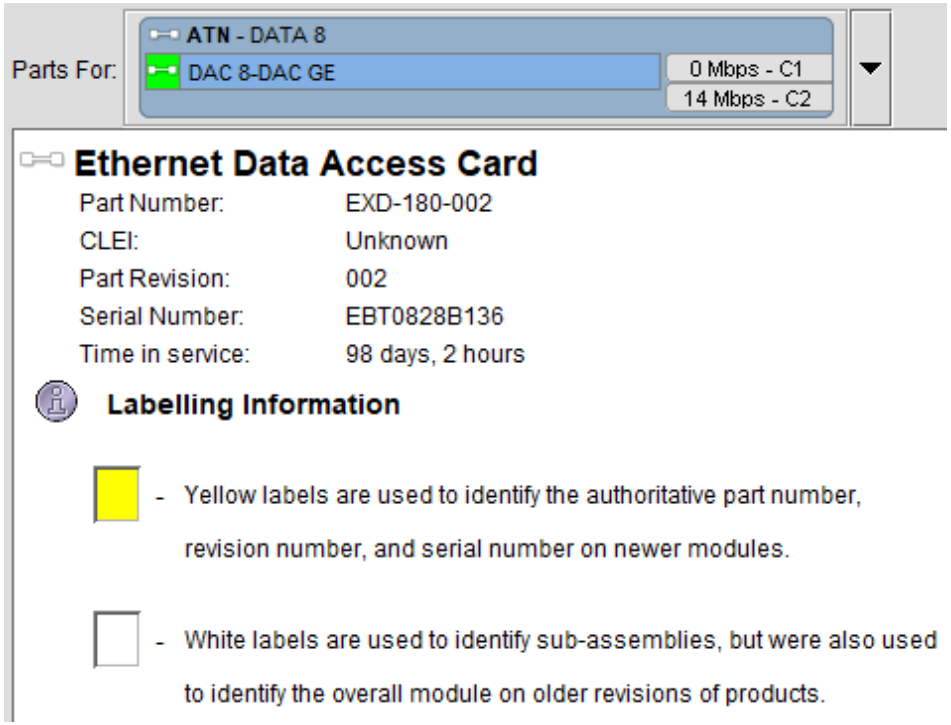
Nota: la captura del estado se registra el 23 de mayo de 2023. Se recomienda cambio de NCC, DAC 16xE1/DS1 v2, DAC GE por obsolescencia tecnológica e instalación de la tarjeta NPC.

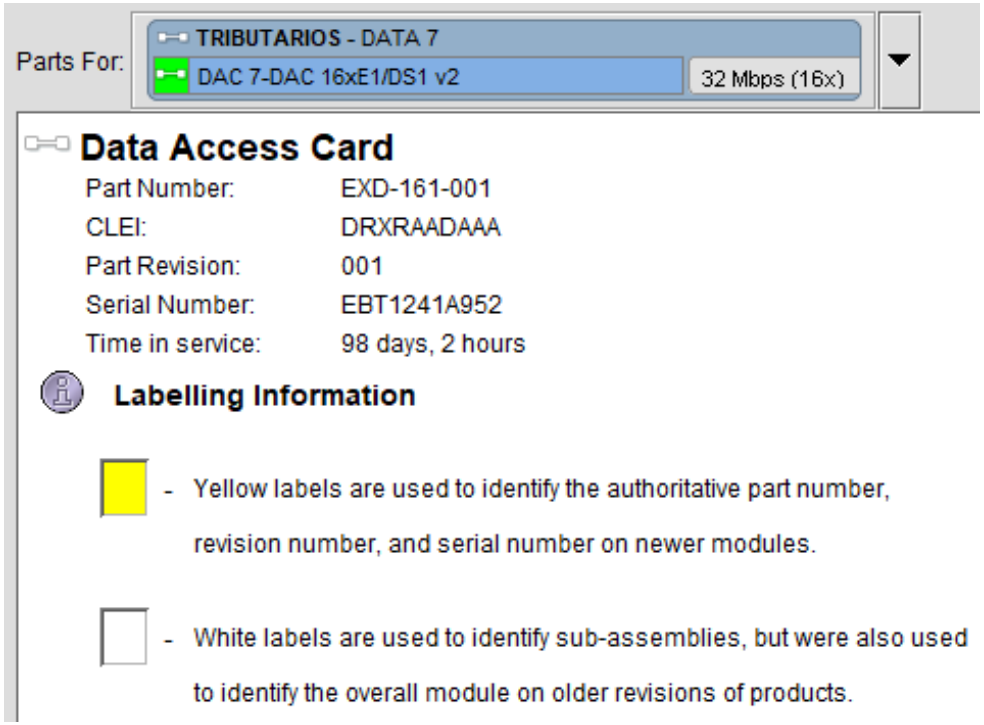
La tarjeta NCC con Serial Number: LEA**0440**0019 (fabricada en 2004, semana 40).

La tarjeta DAC GE con Serial Number: EBT**0828**B136 (fabricada en 2008, semana 28). Mientras que la tarjeta DAC 16xE1/DS1 con Serial Number: EBT**1241**A952 (fabricada en 2012, semana 41)

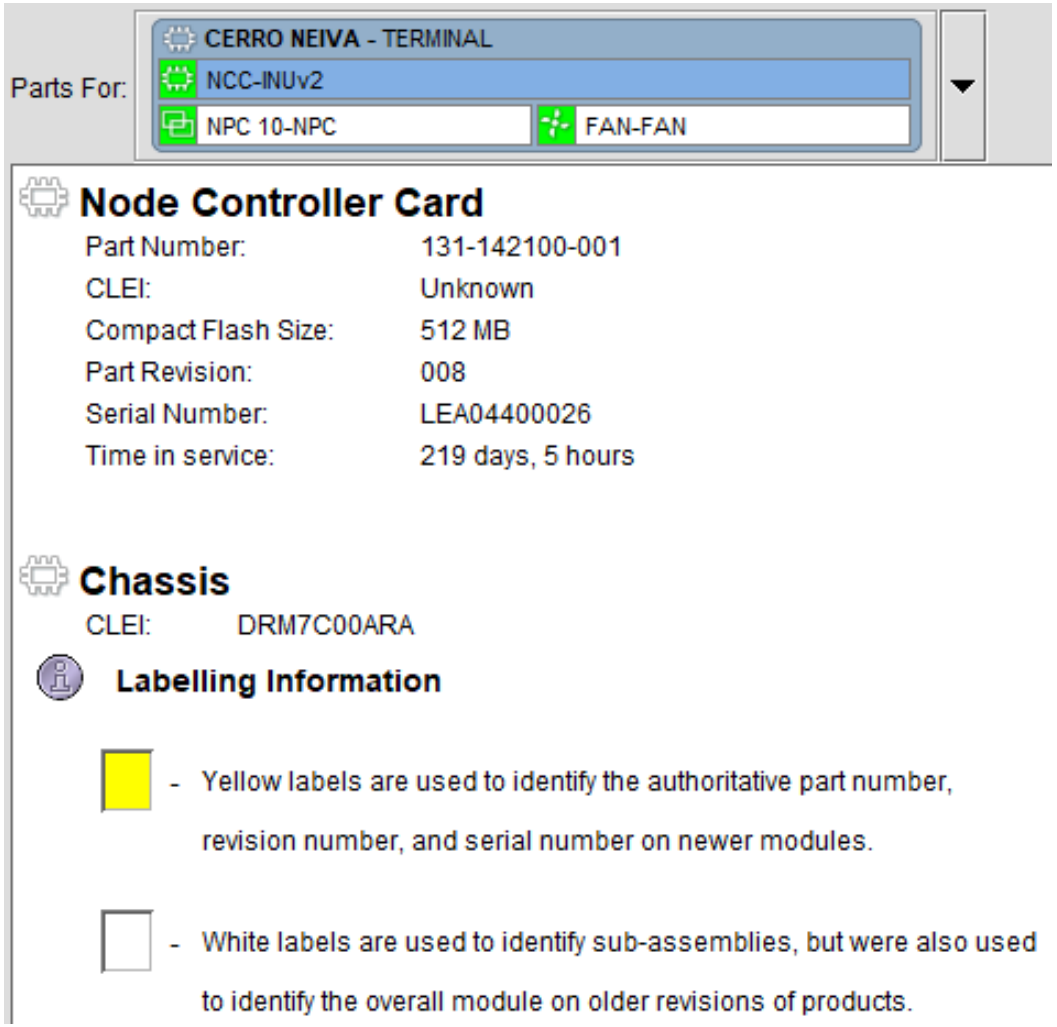
CERRO NEIVA

Nota: la captura del estado se registra el 23 de mayo de 2023. Se requiere cambio de ODU 600 en falla por una ODU 600 v2. Se recomienda cambio de NCC, DAC 16xE1/DS1 v2, DAC GE por obsolescencia tecnológica, retiro de tarjeta AUX y suministro de modulo FAN.
